Miami Herald "SICK" Infrared Detector Retrofit for Baldwin Ultrasonics

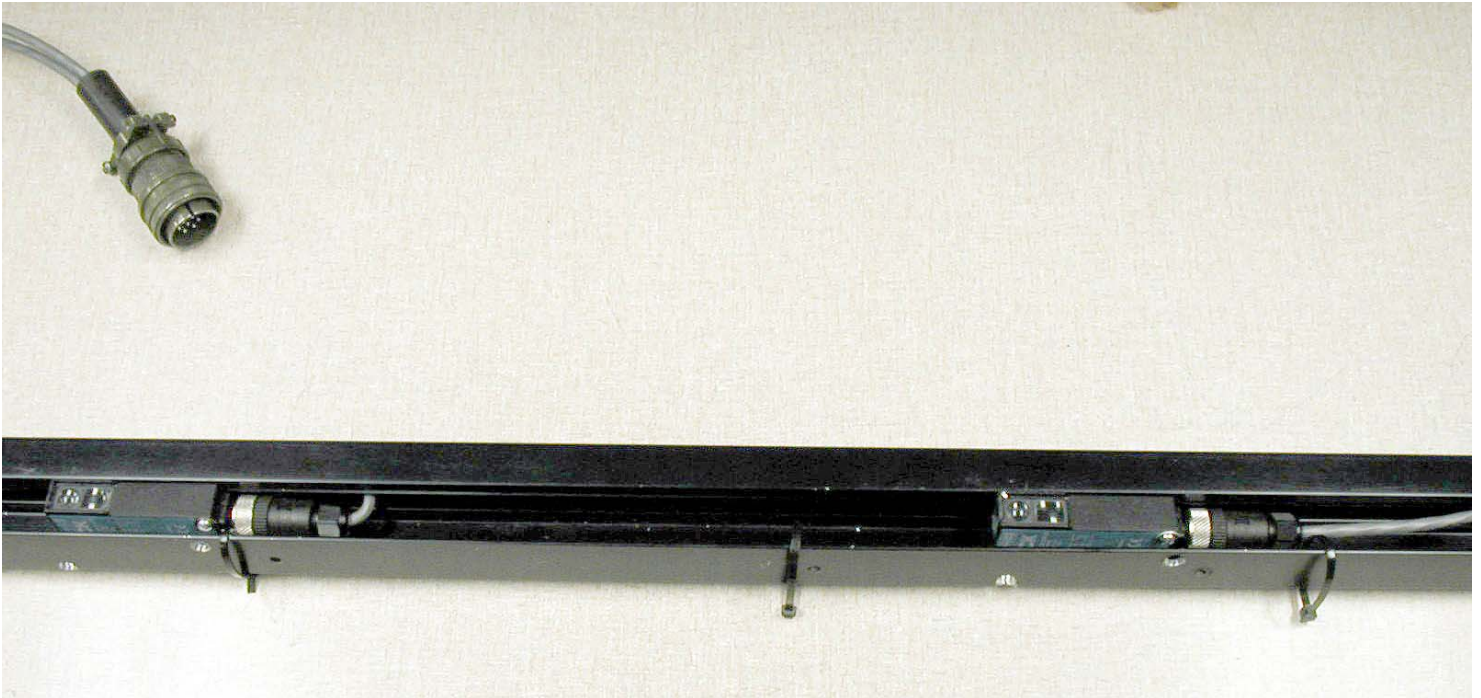
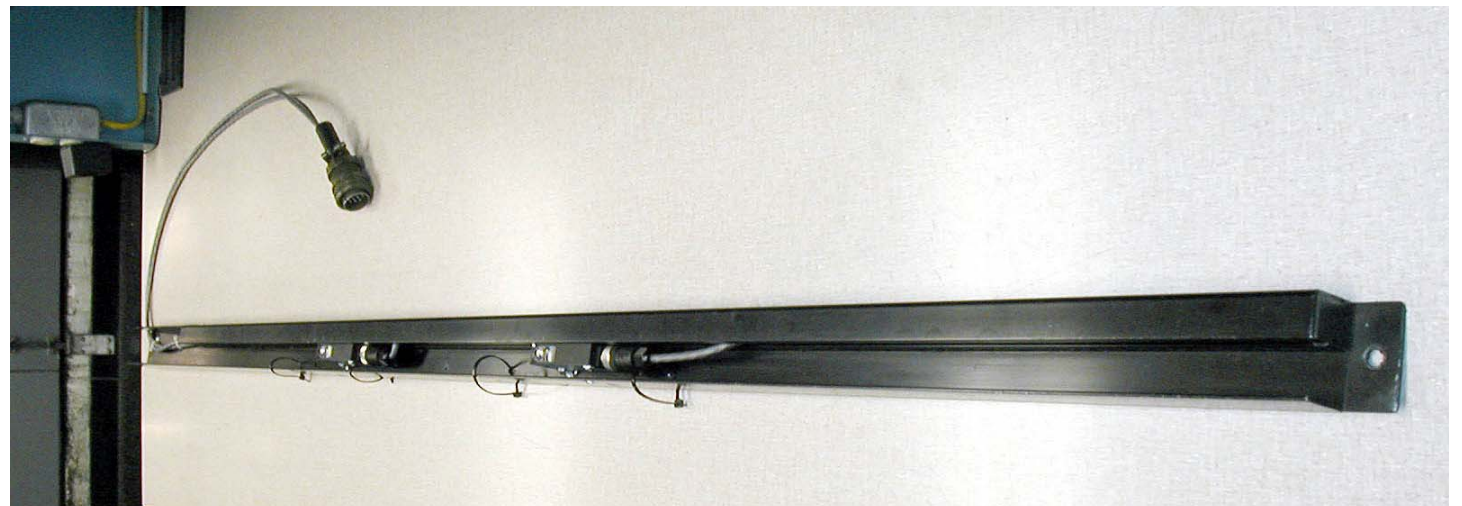
Here is the drawing for the sick detector and pictures. The photoeyes are mounted into our existing 1127/1128 Baldwin bar. The Sick WT18-2N430 is an active low infra-red photoeye. I don't know all of your press interfaces. If you need an active high photoeye, the WT18-2P430 can be used. On the Newsliner, a 2 K-ohm, 1/2 watt resistor is tied from the input to +24V to keep the input high (not floating) when there is no low input from the bar.

The photoeyes are mounted in the bar (unmovable). The reason for this is the pressmen were positioning them too close to the edge of the sheet which caused cutouts. They were also tearing up the cables and connectors. The photoeyes are positioned so they are 4" from the edge of the sheet when running a half roll in middle. They are also in "individual" mode so if either eye does not see the sheet, it is considered a web break. This helps with taper-offs. If you have trouble with "mapped but not sensed" messages at startup caused by one phototeye not covered due to a half roll positioned to the drive or op side, cut a 4" diameter piece of PVC 9" long and have the pressmen slip it over the photoeye that is not being used. Only one PVC per bar which is all that you will need. Drill holes and place ty-wraps through the holes and around the bar on each side of the photoeye 10" apart (see picture). This will keep the PVC from vibrating and moving off the unused eye.

You will want to drill some access holes for the photoeye mounting holes (2) and the phototeye sensitivity adjustment (1). The photoeye has an adjustment range of 2" to 27" which is nice for those situations when you can't get the bar close enough. If you have any questions, please call me at 305-376-2898 or email me at icollins@herald.com. I hope that this helps. 5/10/04
